**Application Form**  
**Submitted By: Anonymous user**  
**Submitted Time:**  
**February 22, 2022 11:55 AM**

**PLUS ID: 2022-03-06**

**PLUS Application Type - Site Plan Review**

**Title:** Middletown Storage

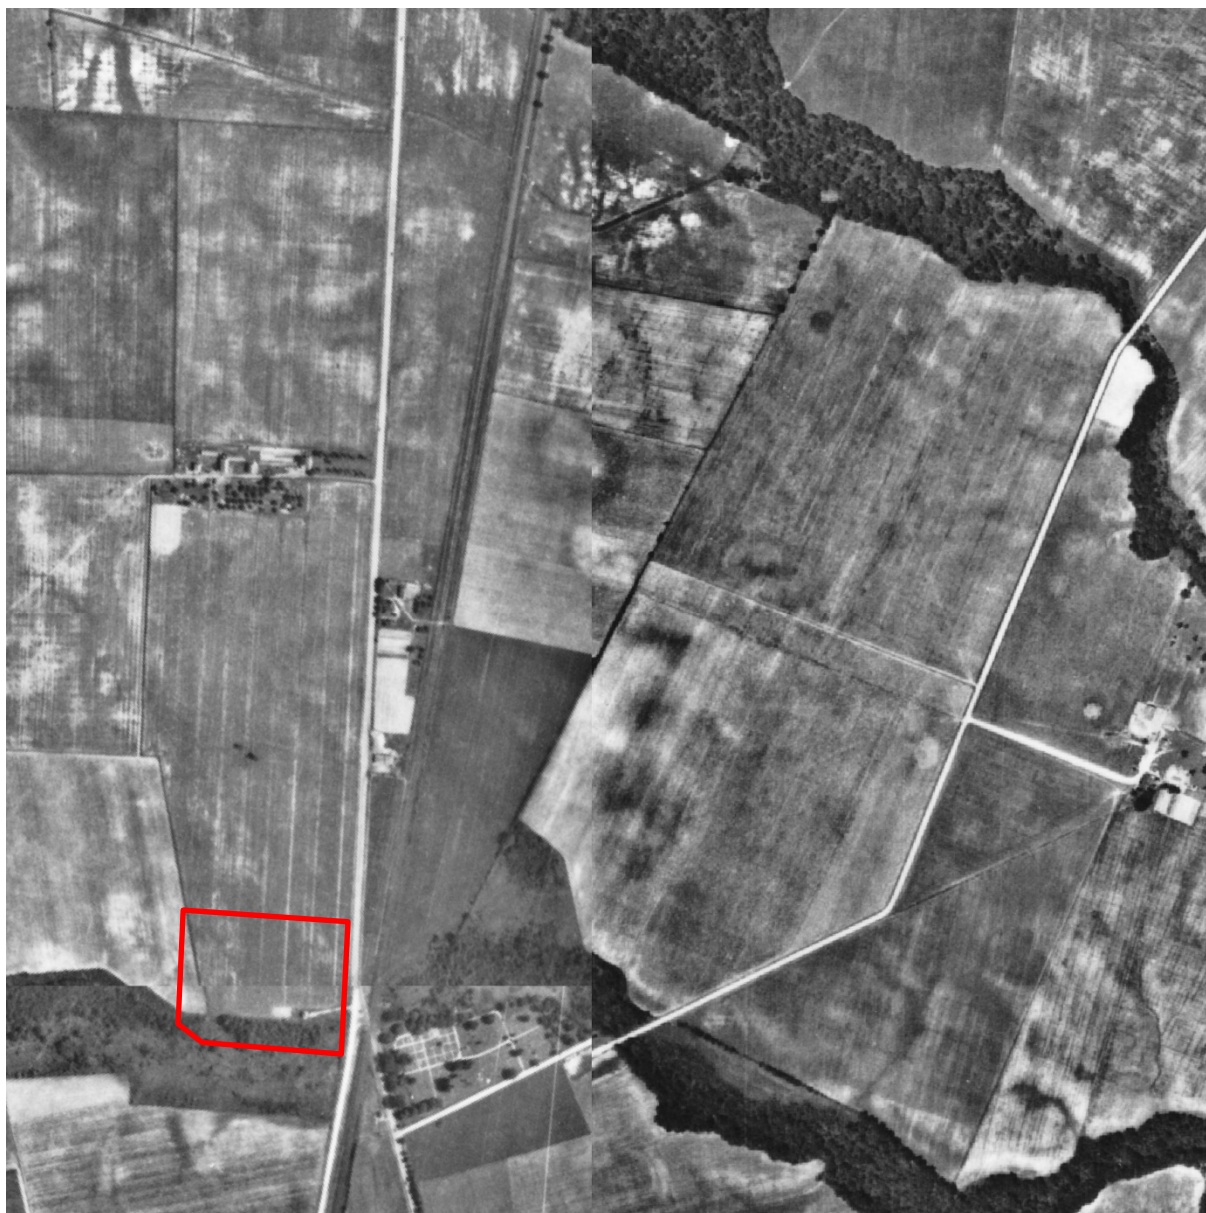
**Figure 1: 1937 Aerial Photo**

The 1937 aerial photo depicts the northern and central portions of the site in agricultural use with a swale near the western boundary and young woodlands in the south. A structure appears north of the woodlands along Summit Bridge Road.

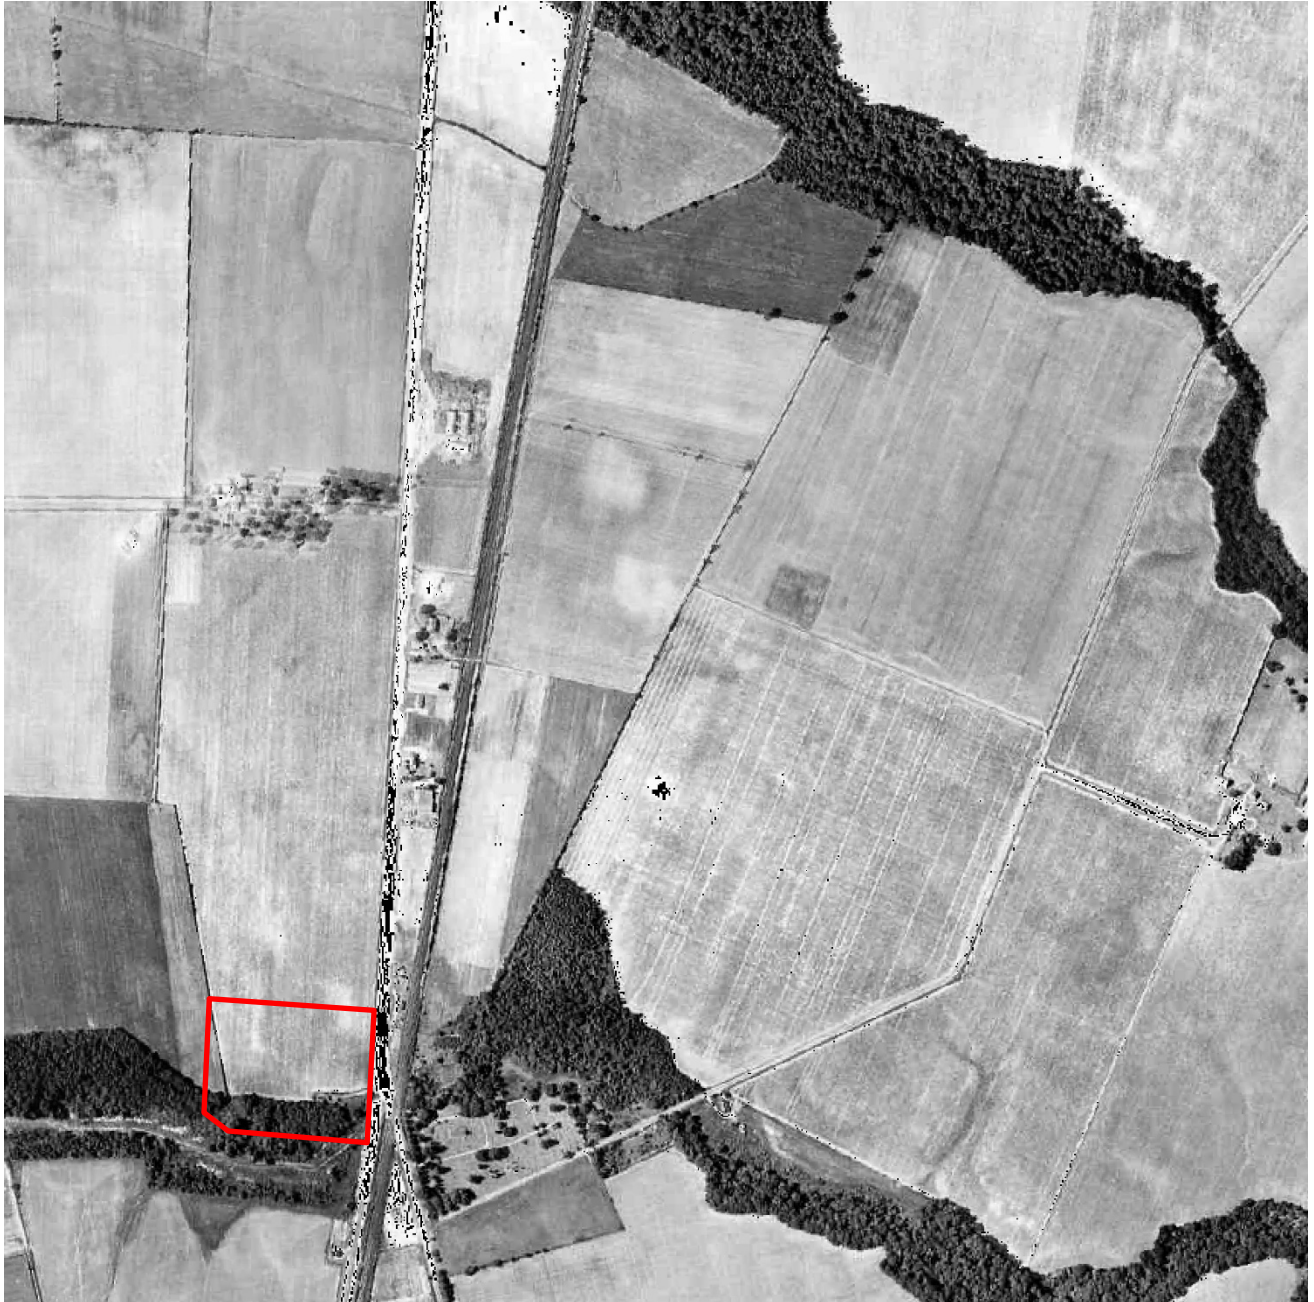
**Figure 2: 1954 Aerial Photo**

The 1954 aerial photo depicts the majority of the site remains in agricultural production. Widening of Summit Bridge Road and straightening of the stream along the southern boundary are apparent.

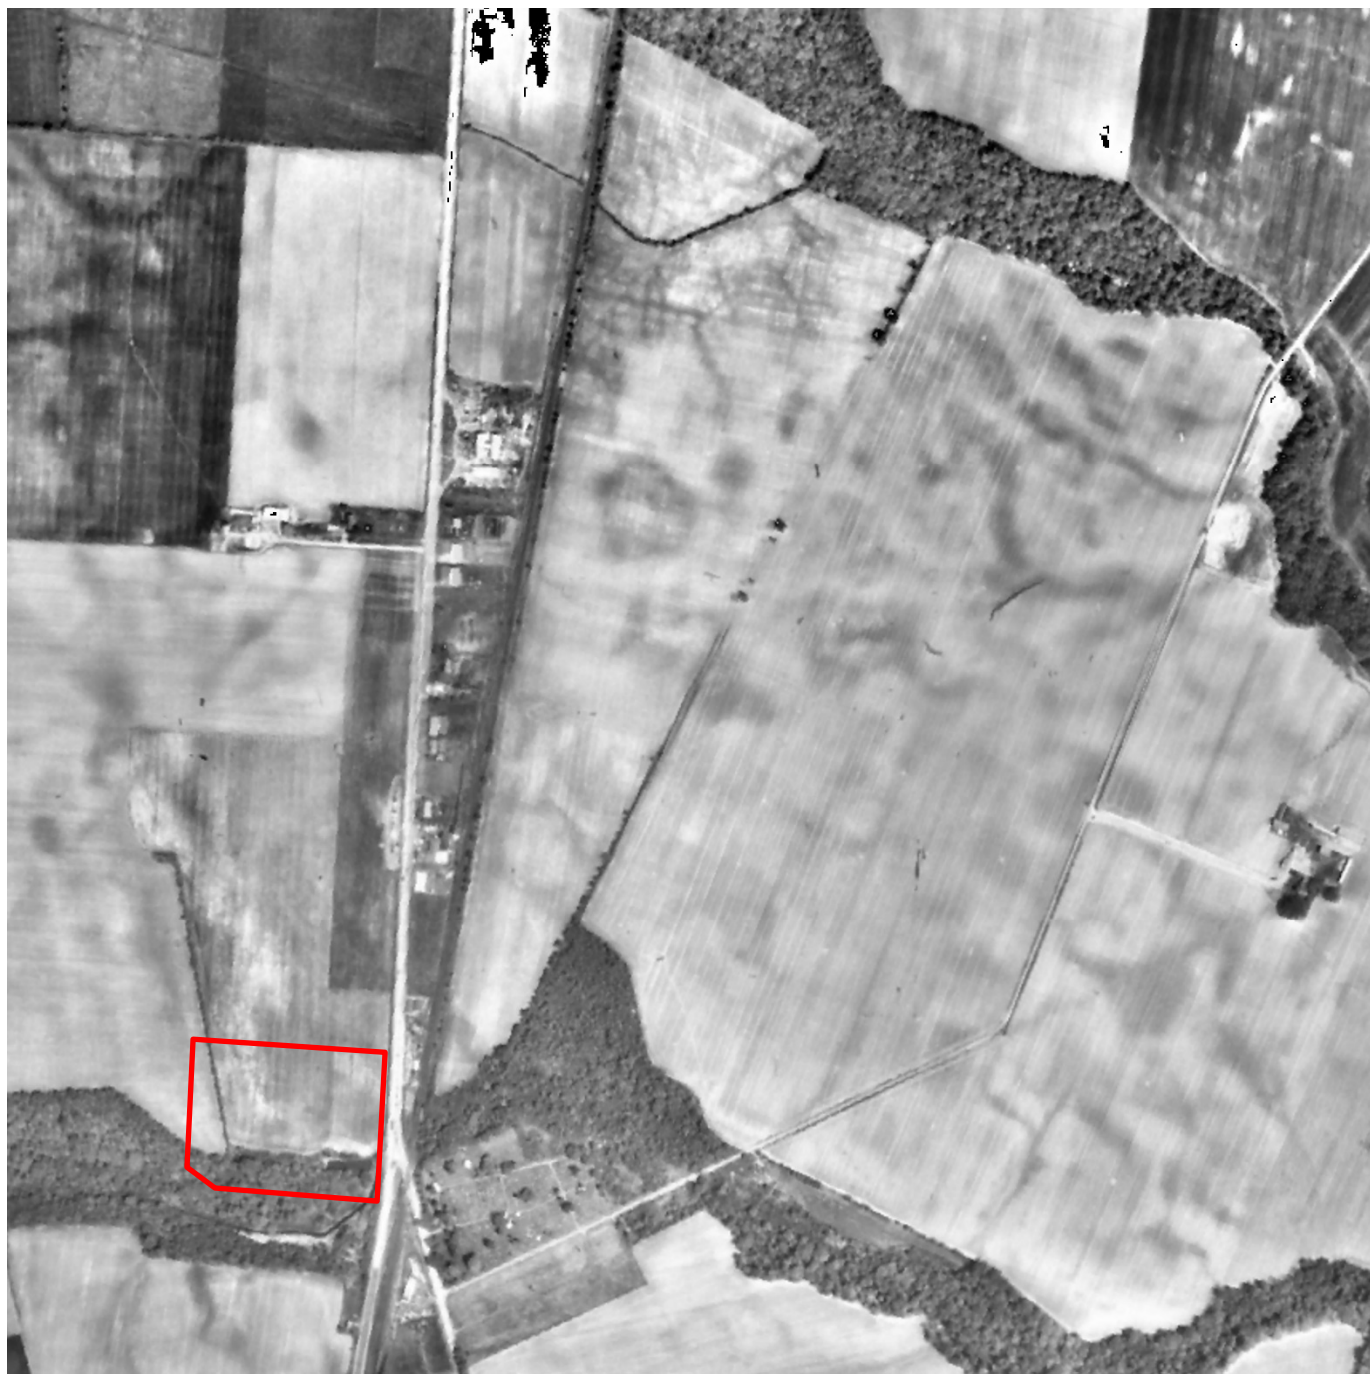
**Figure 4: 1968 Aerial Photo**

The 1968 aerial photo depicts the majority of the site remaining in agricultural use. Woody vegetation is colonizing along the swale in the southwestern portion of the property. Land disturbance is apparent along the stream channel on the adjacent property to the south.

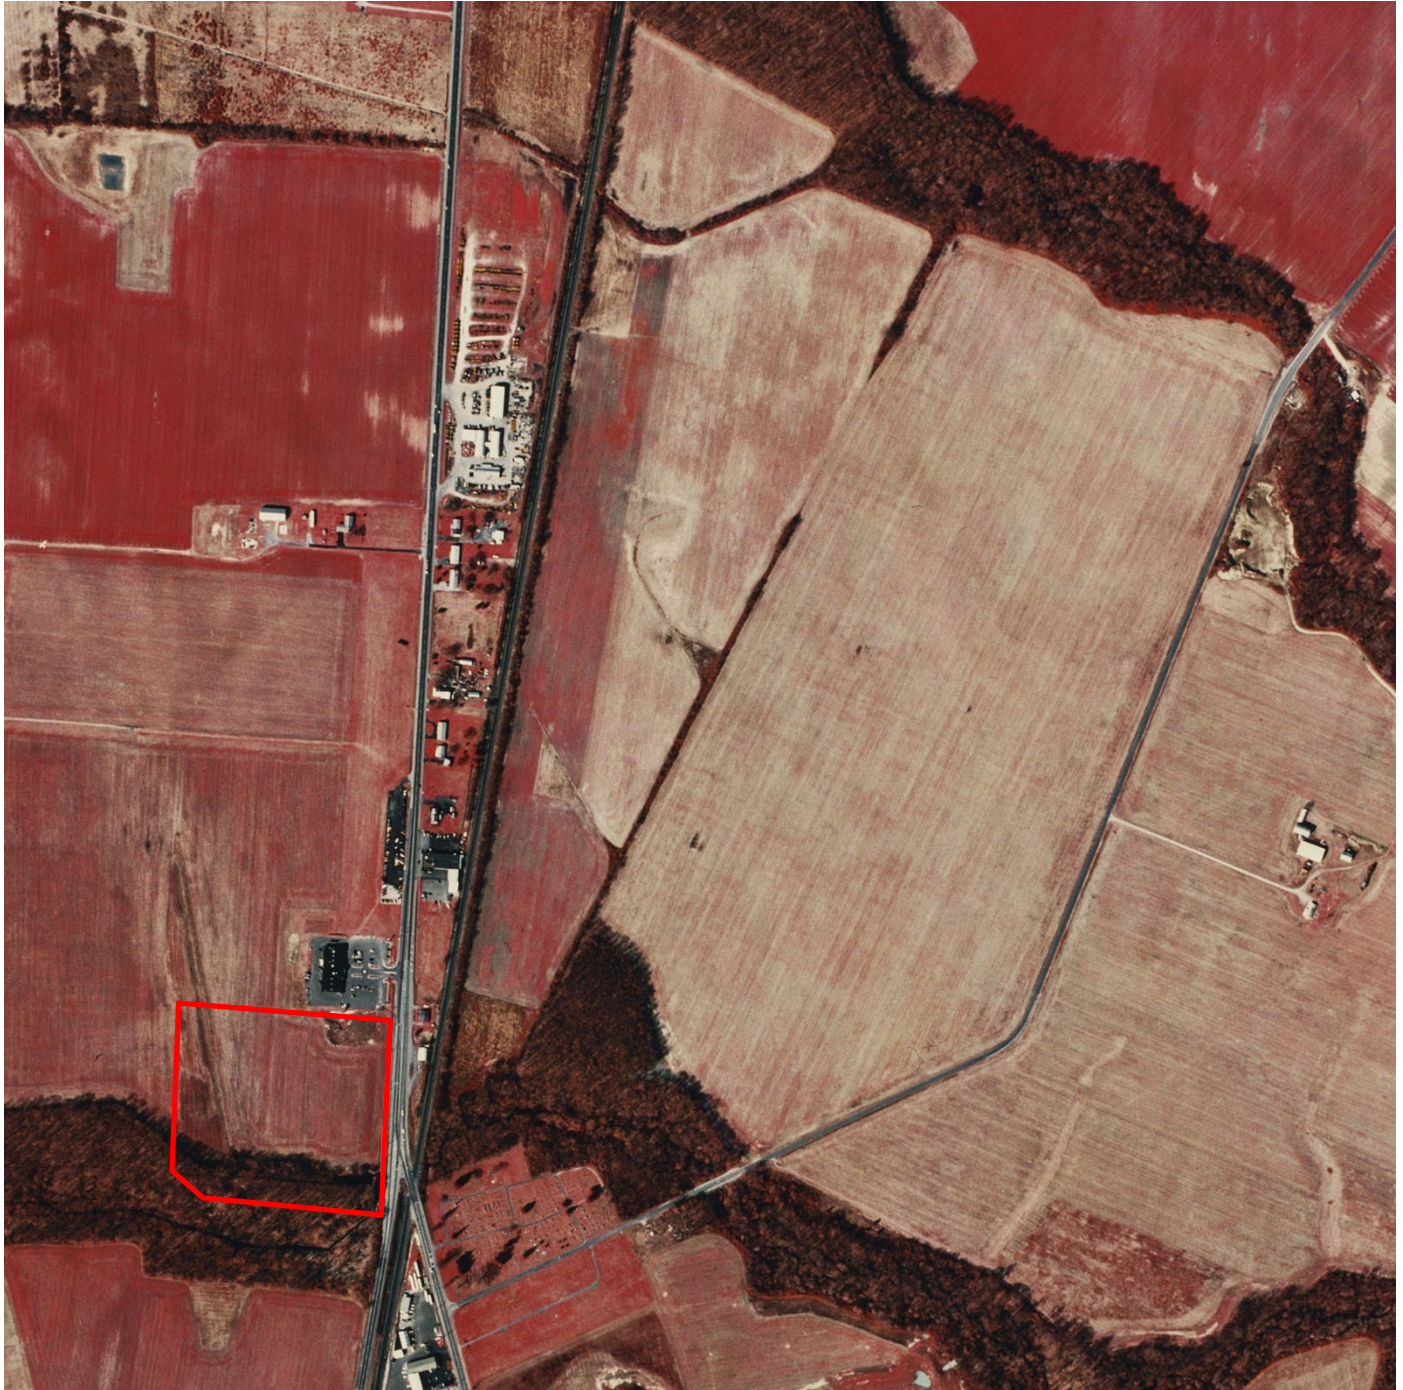
**Figure 5: 1992 Aerial Photo**

The 1992 aerial photo depicts construction of a convenience store north of the subject property. The subject property remains in agricultural use and the woody vegetation along the swale has been removed.

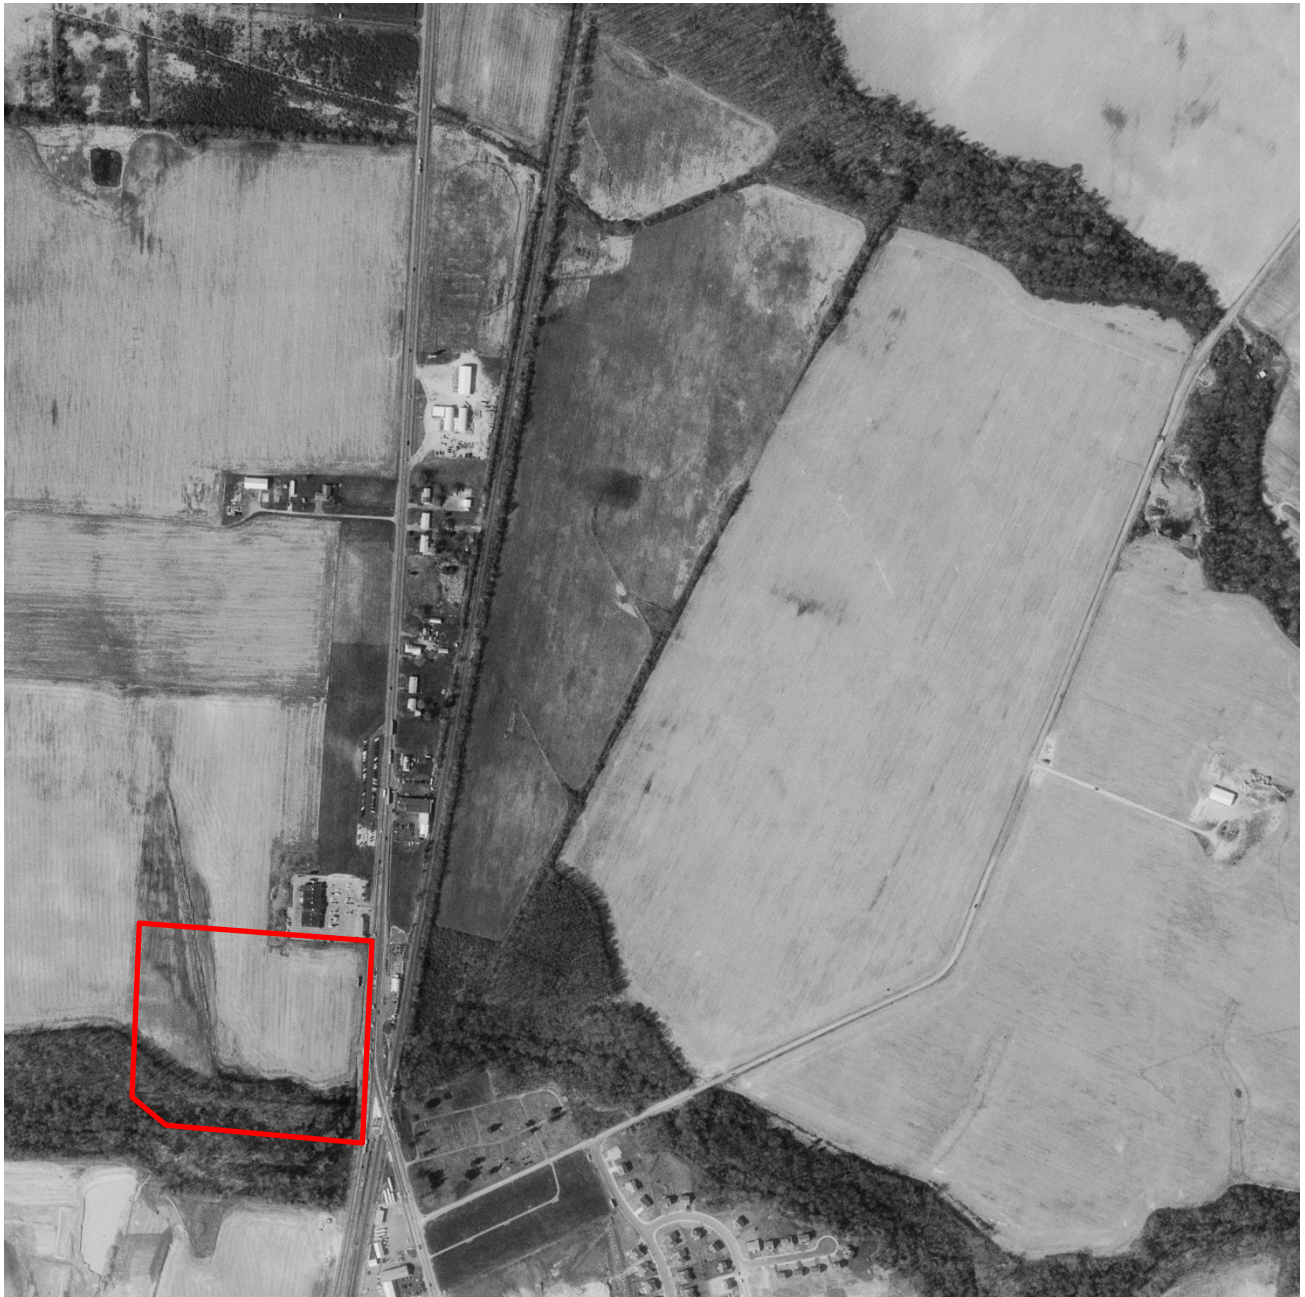
**Figure 6: 1997 Aerial Photo**

The 1997 aerial photo depicts similar conditions as the 1992 imagery within the subject property.

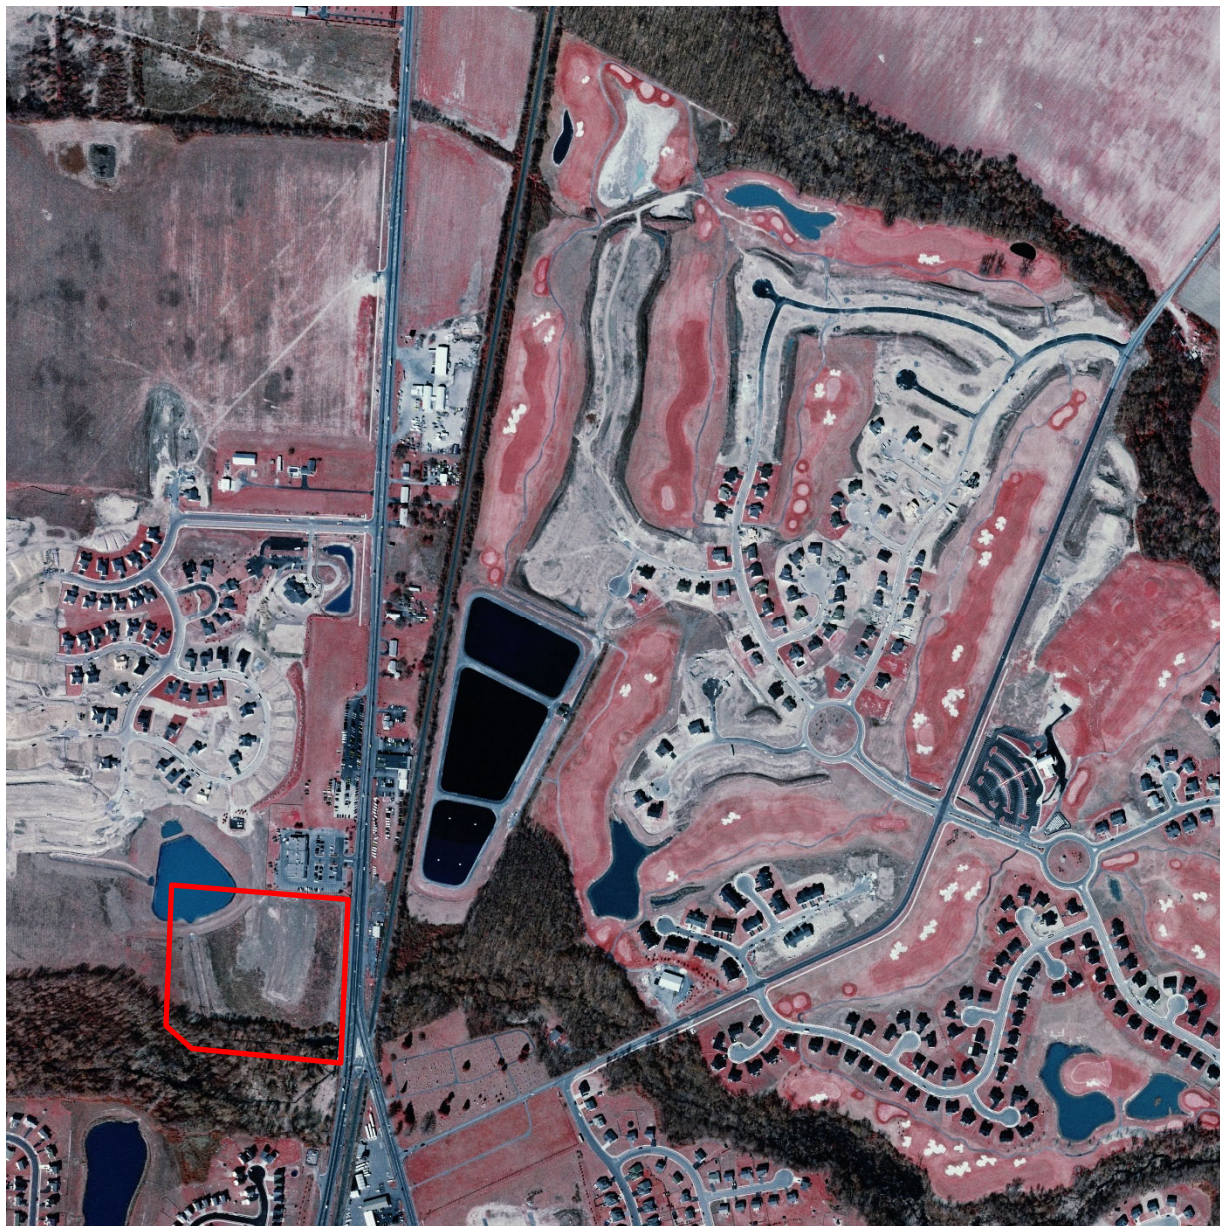
**Figure 7: 2002 Aerial Photo**

The 2002 aerial photo depicts construction of the adjacent stormwater pond in the northwest corner and construction within the ditch in the western portion of the subject property. Grading activity is evident on the central portion of the subject property. Surrounding land use has changed to residential development north and south of the subject property.

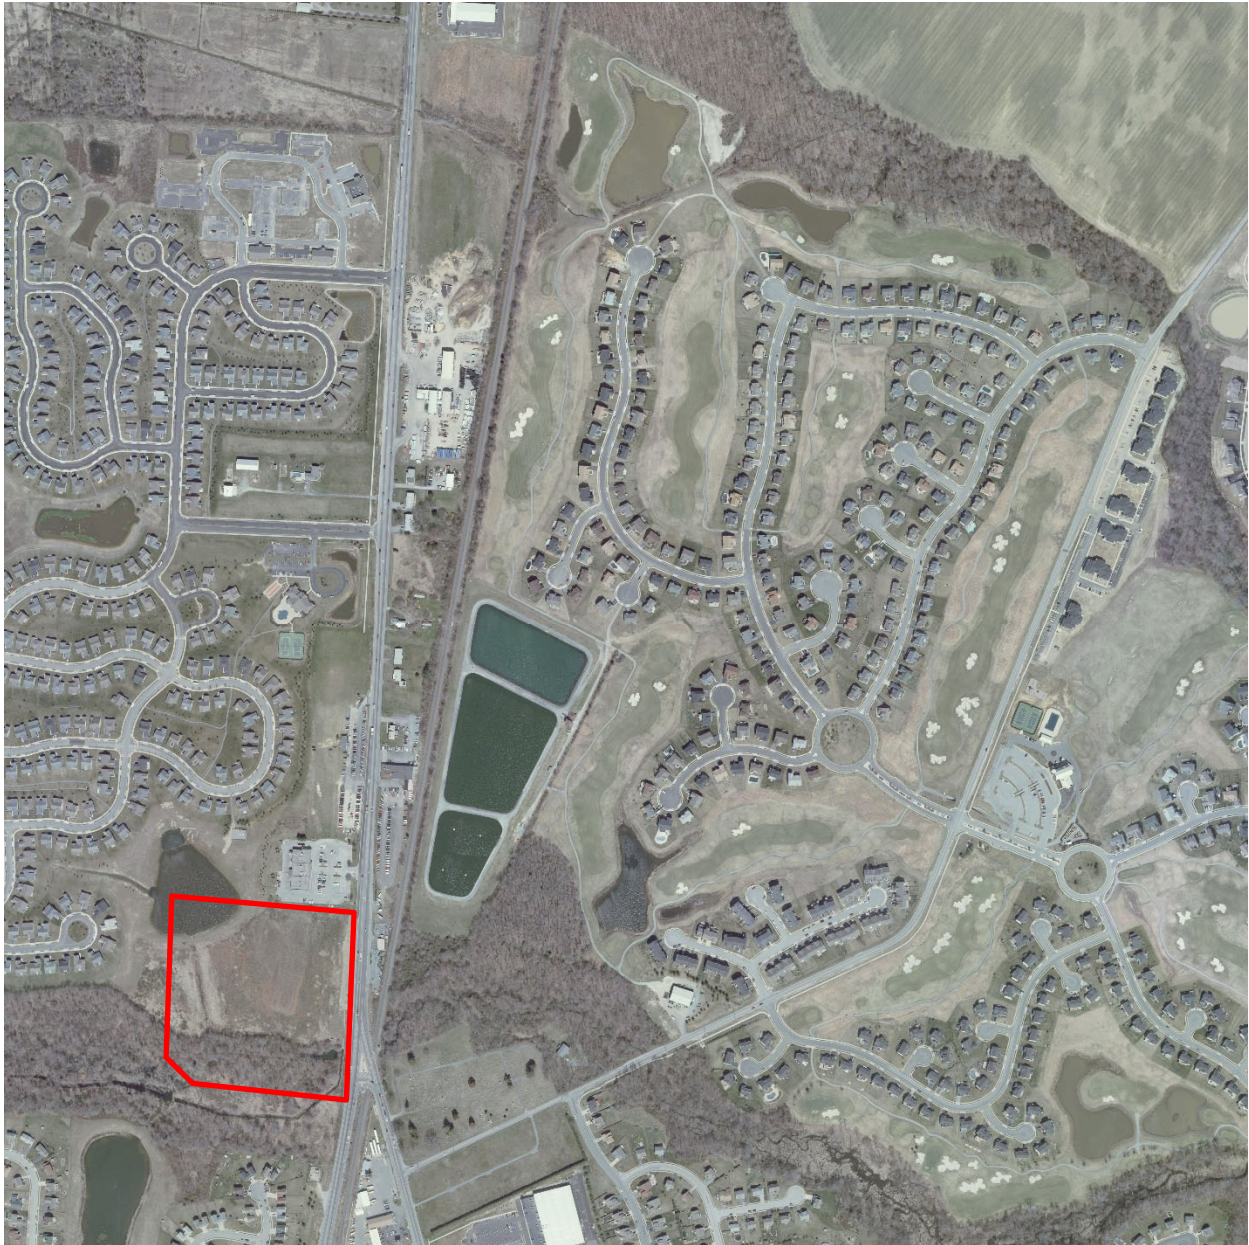
**Figure 8: 2007 Aerial Photo**

The 2007 aerial photo depicts similar conditions to the 2002 aerial. The homes within the residential subdivision to the northwest have been constructed.

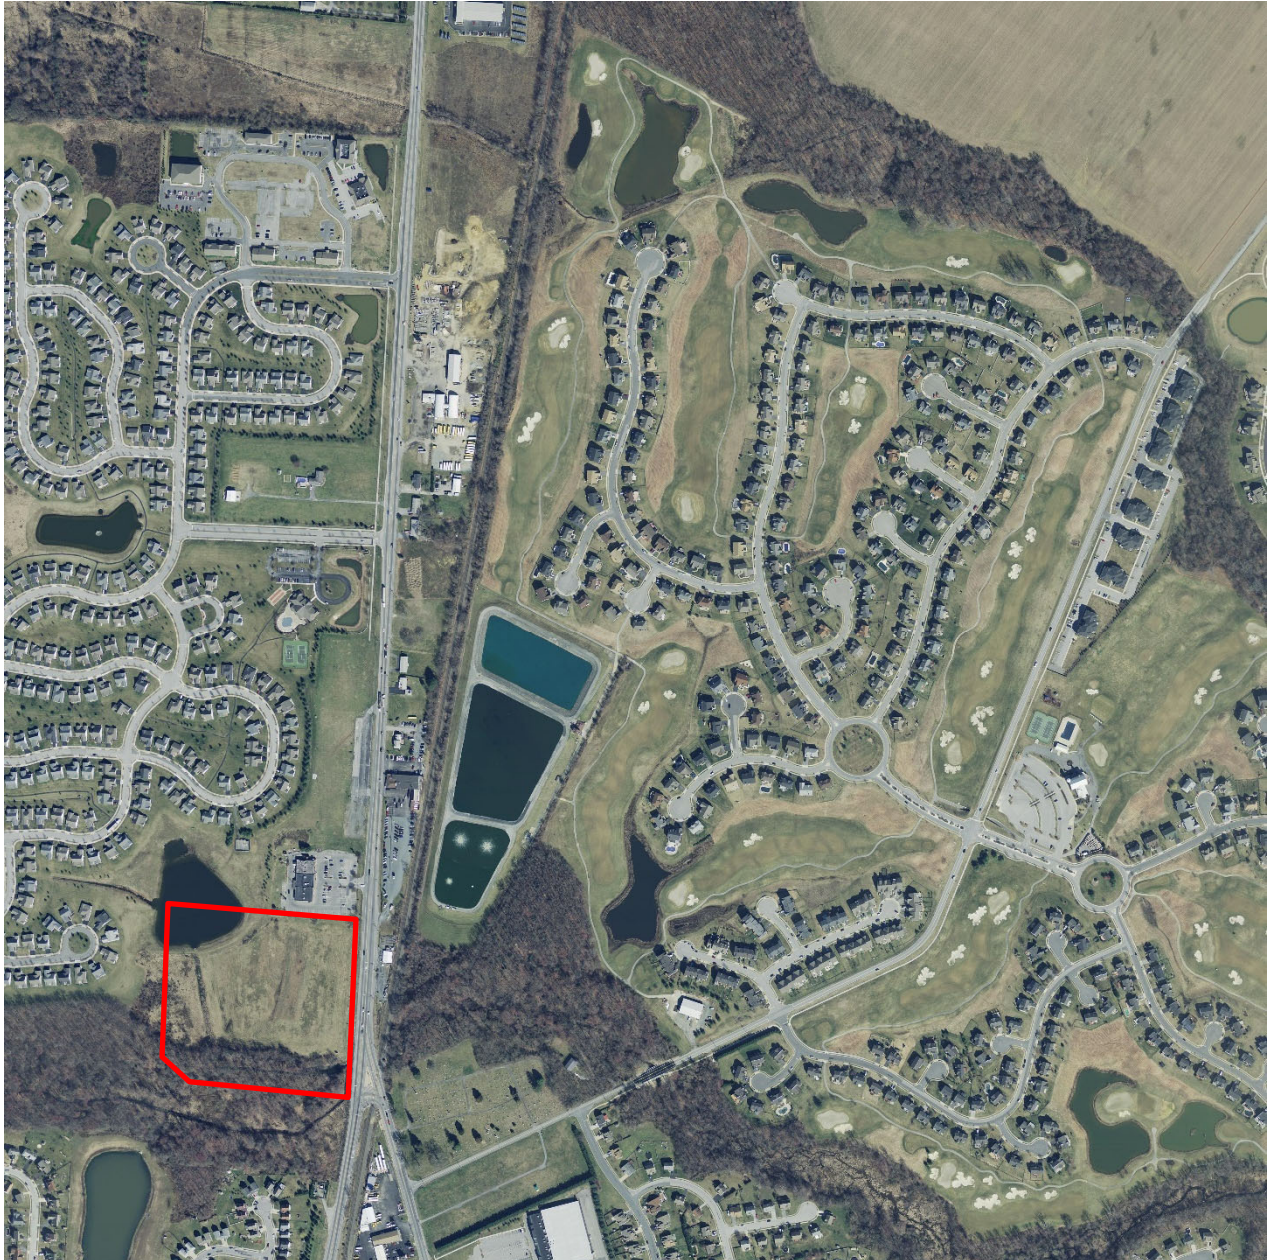
**Figure 9: 2012 Aerial Photo**

The 2012 aerial photo depicts similar conditions to the 2007 aerial imagery. The western portion of the property appears to have been left fallow with pioneering old field vegetation.

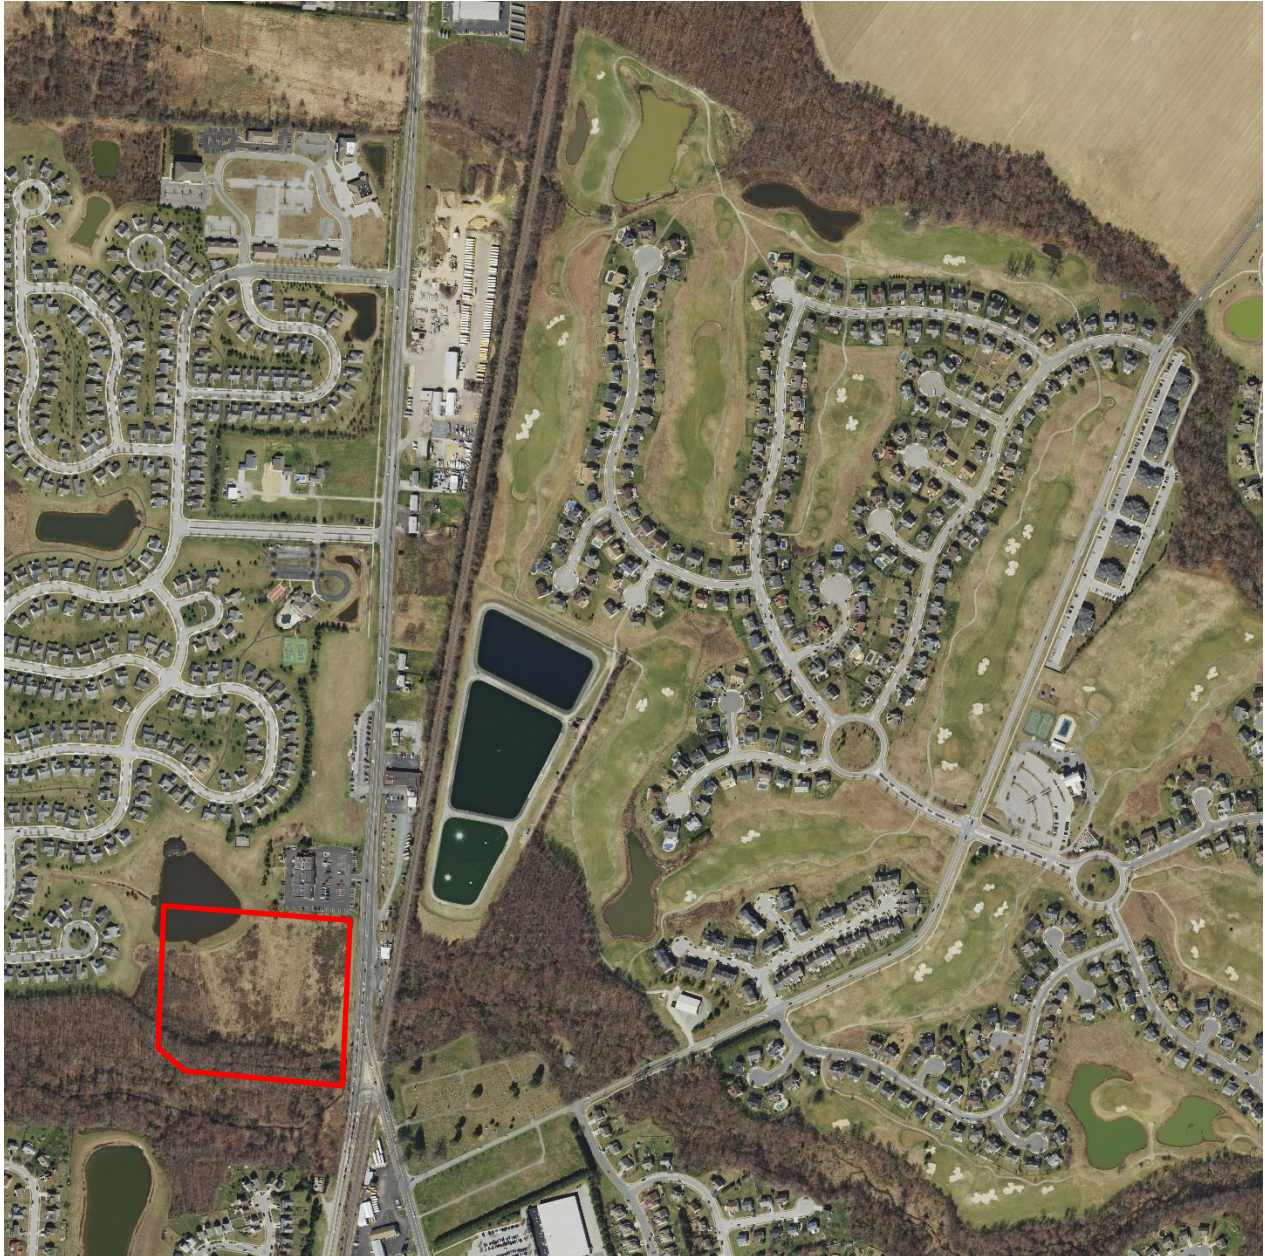
**Figure 10: 2017 Aerial Photo**

The 2017 aerial photo depicts the majority of the subject property is fallow field. The western portion of the property appears to be colonized by woody vegetation with pioneering old field vegetation in the central and eastern portions of the property.

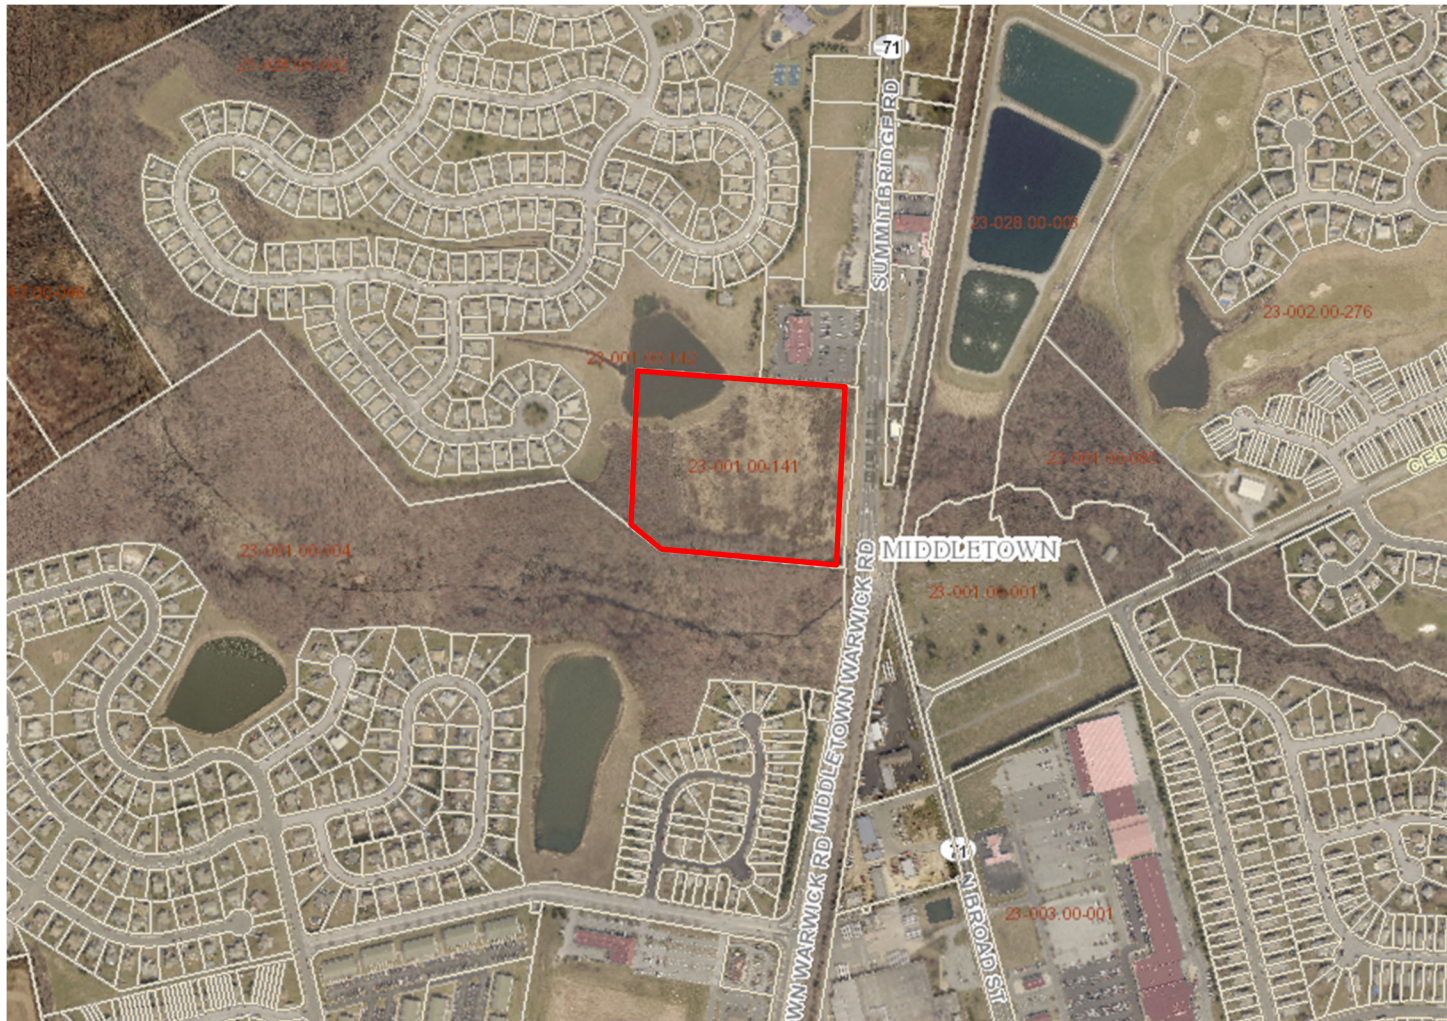
Figure 11: 2019 Aerial Photo

The 2019 aerial photo depicts the majority of the subject property is fallow field. The western portion of the property appears to be colonized by woody vegetation with old field vegetation in the central and eastern portions of the property.

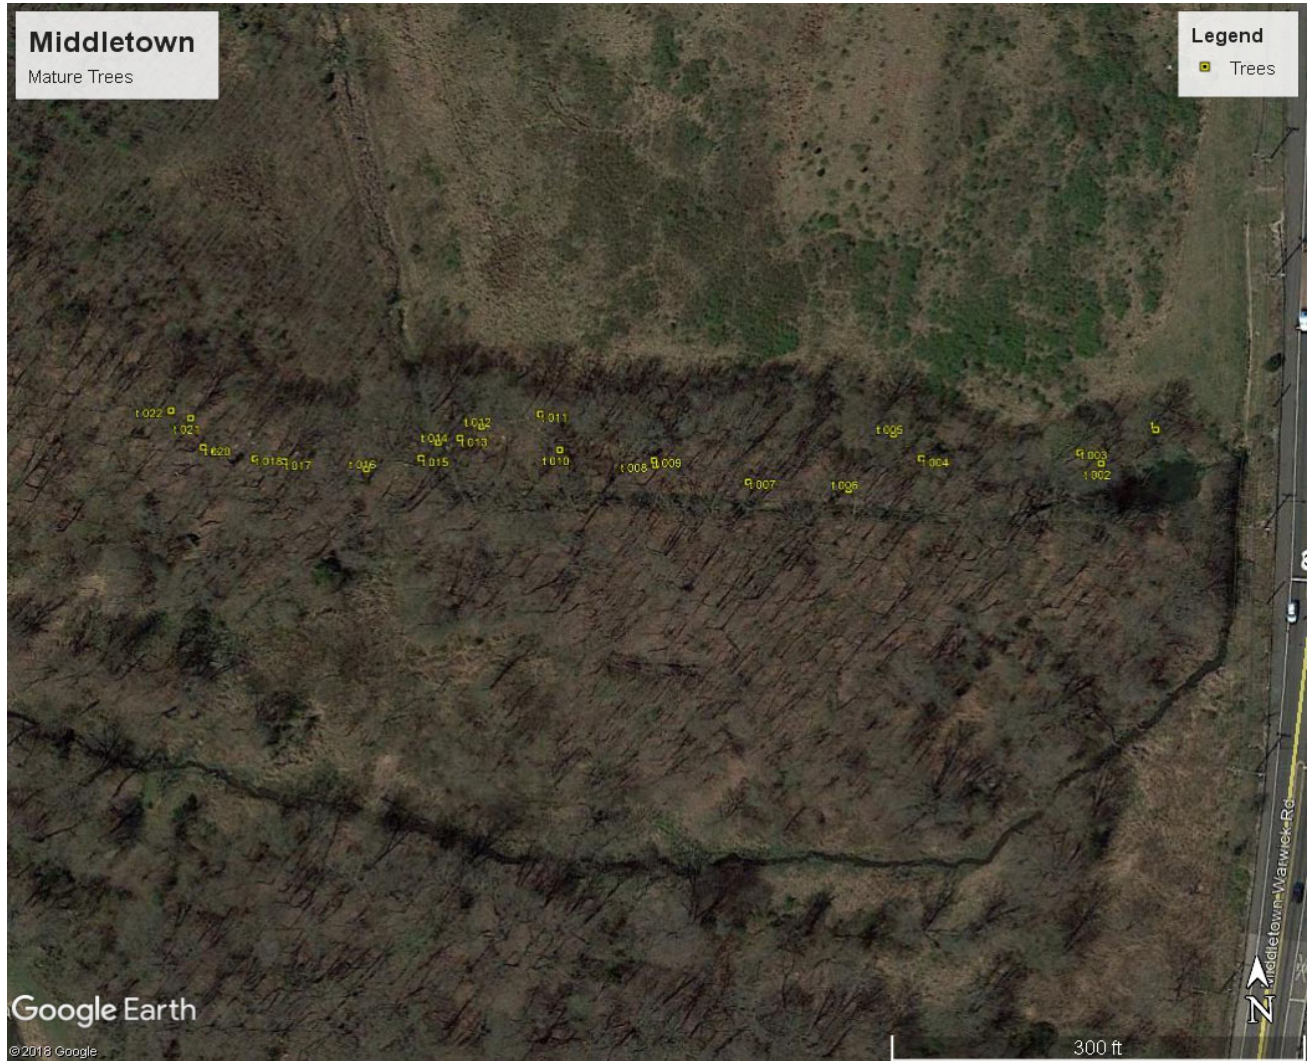
**Figure 13: Mature Tree Mapping**

**Table 2. Trees >16" DBH**

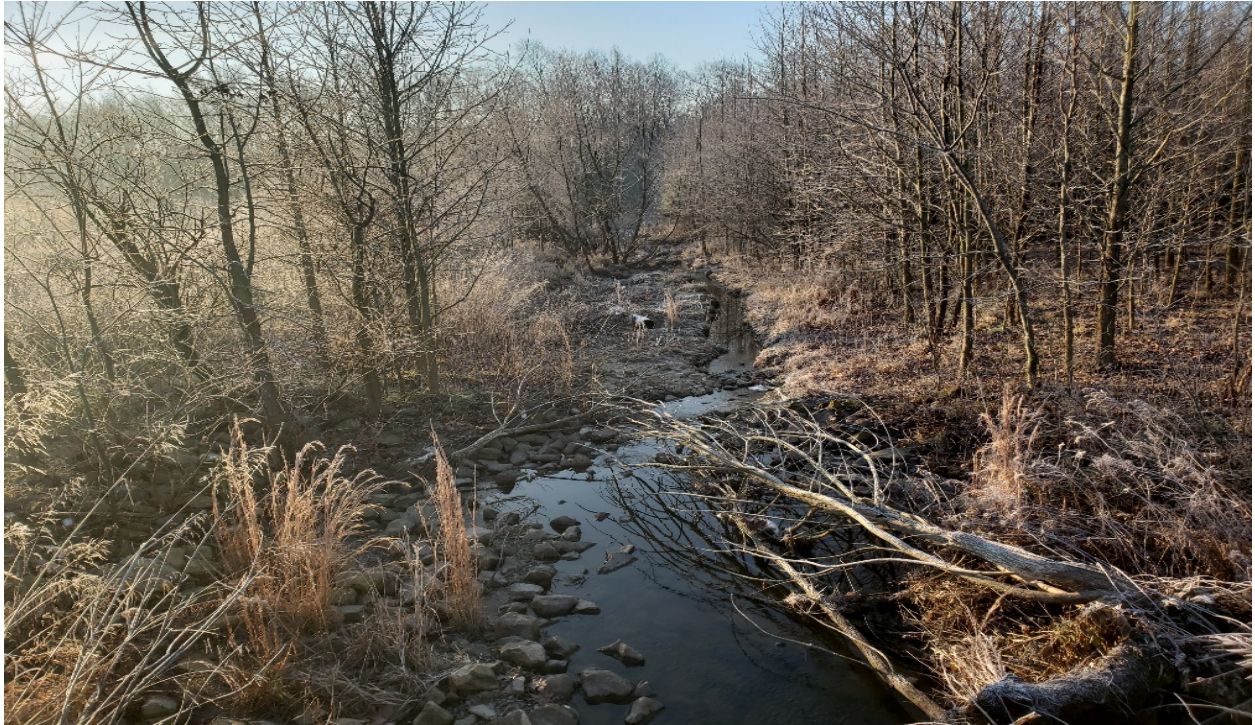
View looking south from outfall of stormwater management facility. Pioneering forest cover to (right) of photo.

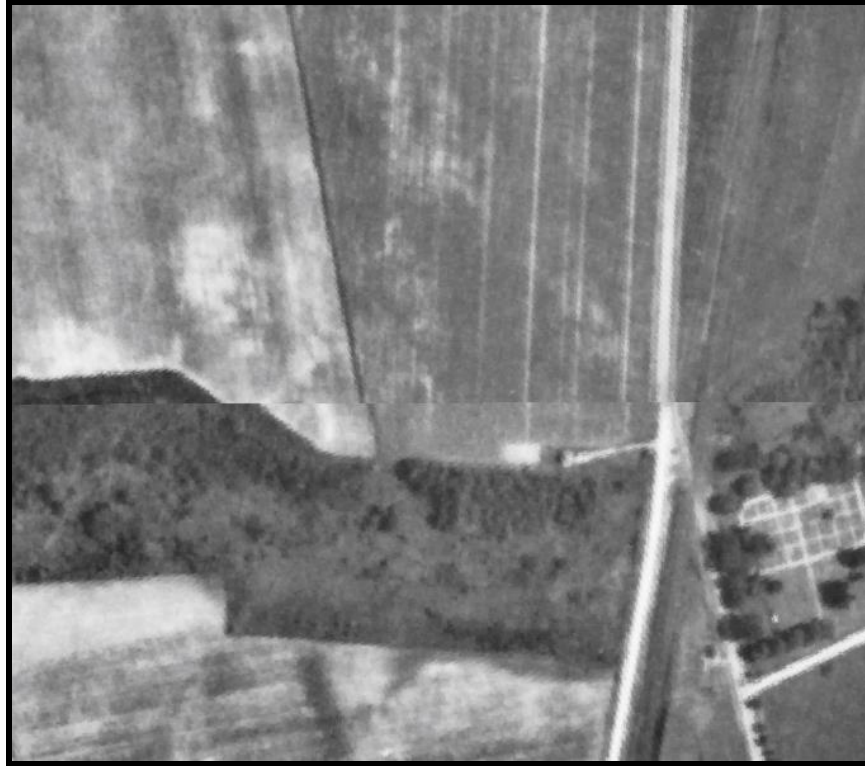
**Figure 2: 1937 Aerial Photo**

The 1937 aerial photo depicts the site in agricultural use with a ditch on the western portion and young woodlands in the south. A home appears north of the woodlands along Summit Bridge Road.

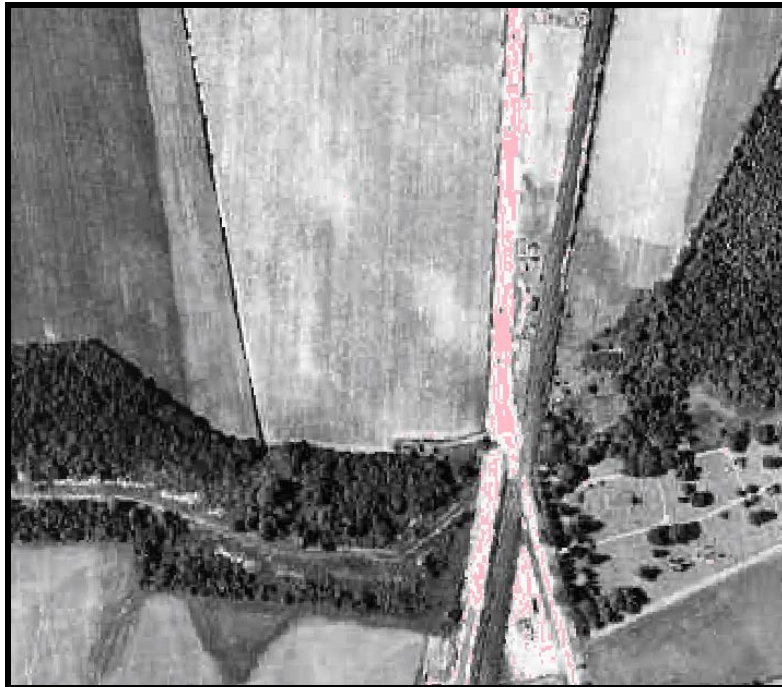
**Figure 3: 1954 Aerial Photo**

The 1954 aerial photo depicts widening of Summit Bridge Road and straightening of the stream along the southern boundary. The majority of the site remains in agriculture.

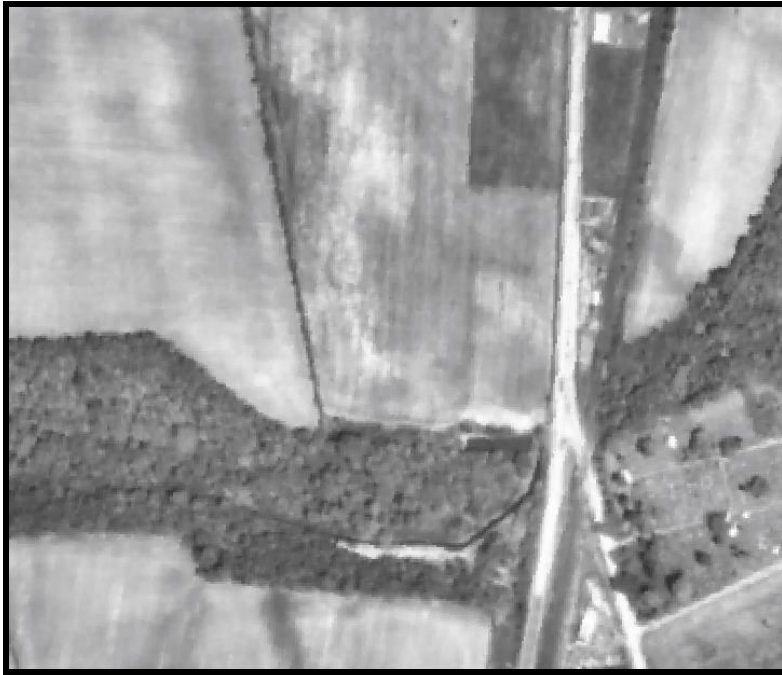
**Figure 4: 1968 Aerial Photo**

The 1968 aerial photo depicts similar conditions to 1954 with some additional stream work to the south, likely dredging.

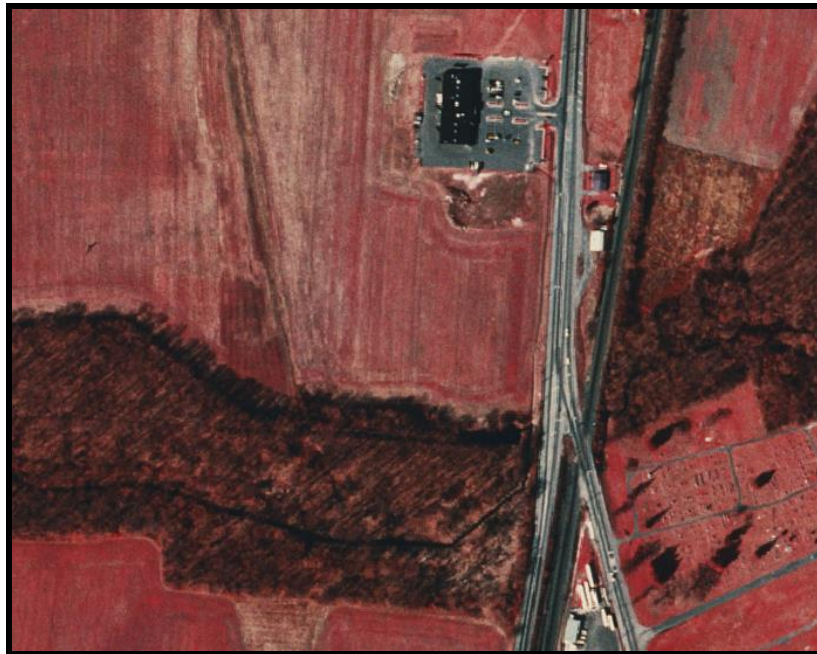
**Figure 5: 1992 Aerial Photo**

The 1992 aerial photo depicts the adjacent shopping center and the Subject Property is still in agriculture.

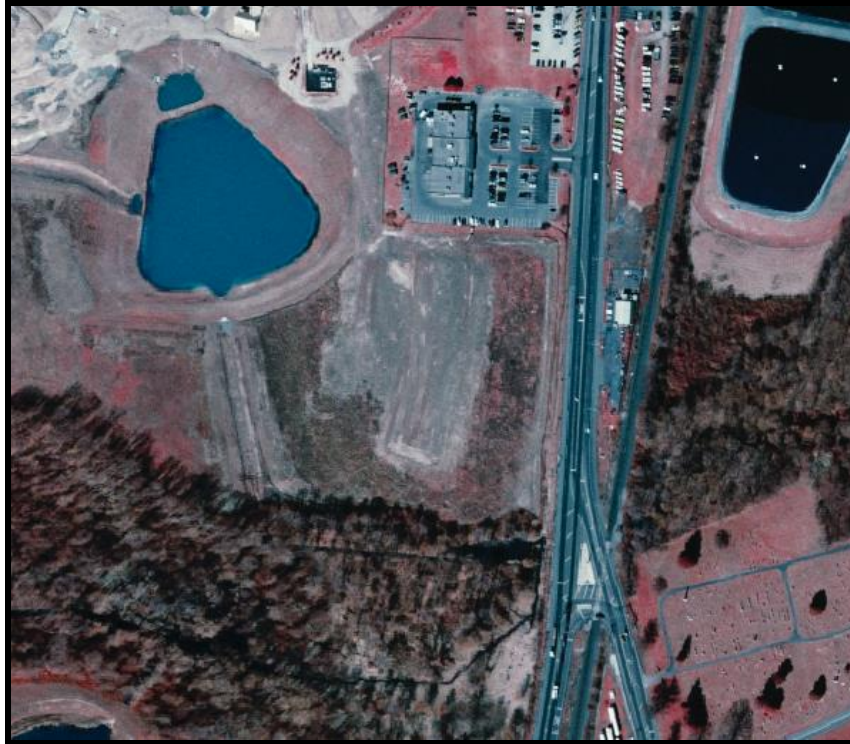
**Figure 6: 2002 Aerial Photo**

The 2002 aerial photo depicts construction of the adjacent pond, work on the ditch in the west and the adjacent housing development under construction. Grading activity is evident on the central portion of the site.

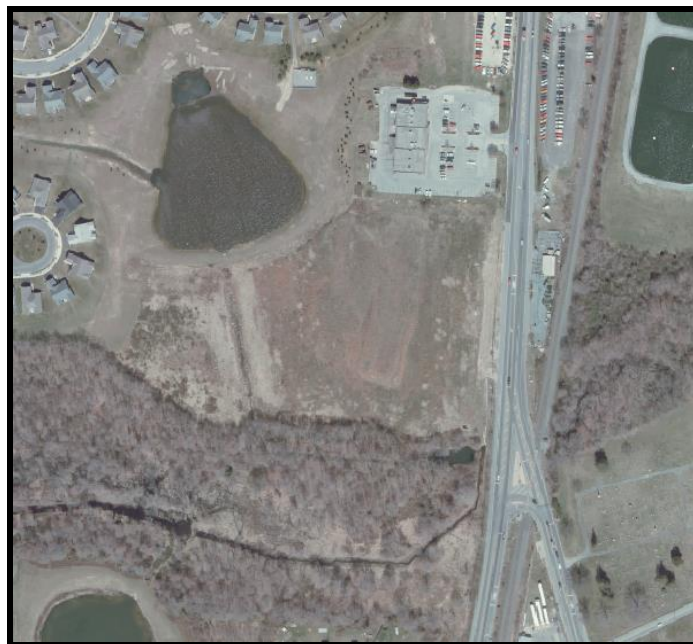
**Figure 7: 2007 Aerial Photo**

The 2007 aerial photo depicts similar conditions to the 2002 aerial.
