**Application Form**  
**Submitted By: Anonymous user**  
**Submitted Time:**  
**February 22, 2022 11:55 AM**

**PLUS ID: 2022-03-06**

**PLUS Application Type - Site Plan Review**

**Title:** Middletown Storage

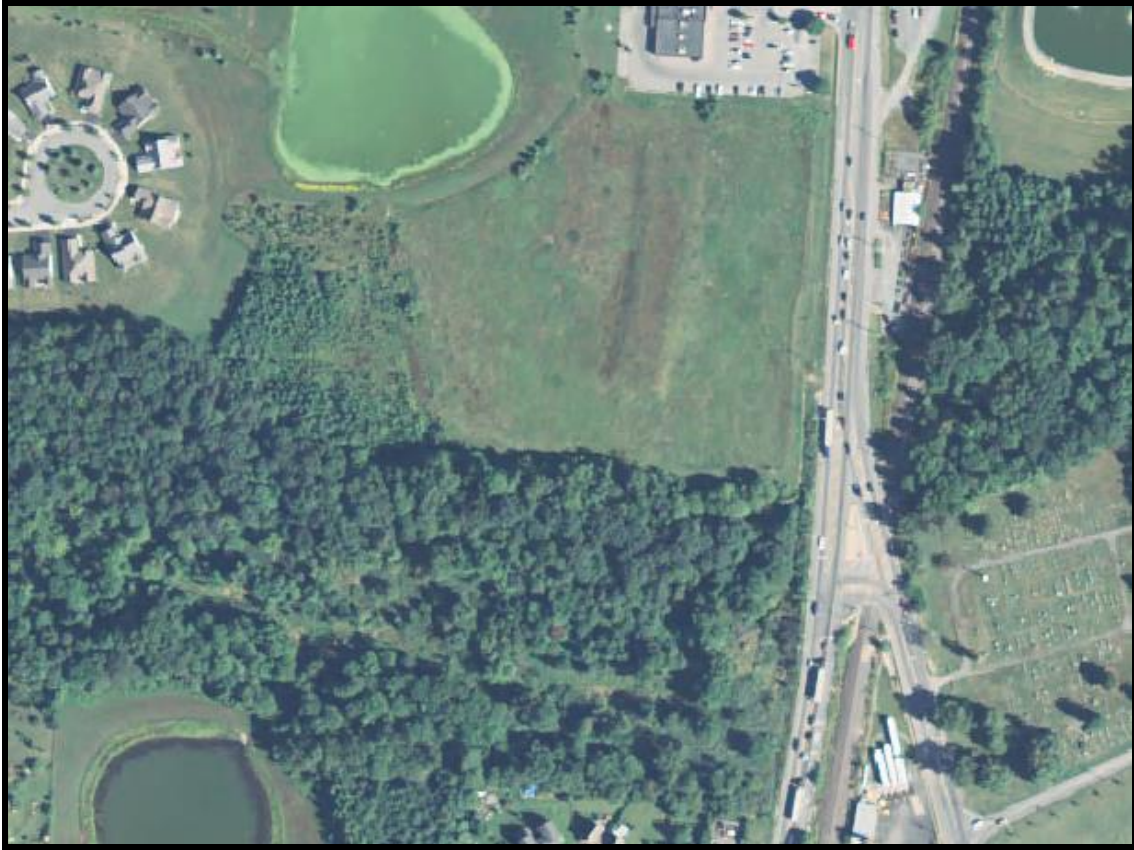
**Figure 8: 2013 Aerial Photo**

The 2013 aerial photo depicts similar conditions to the current site conditions.

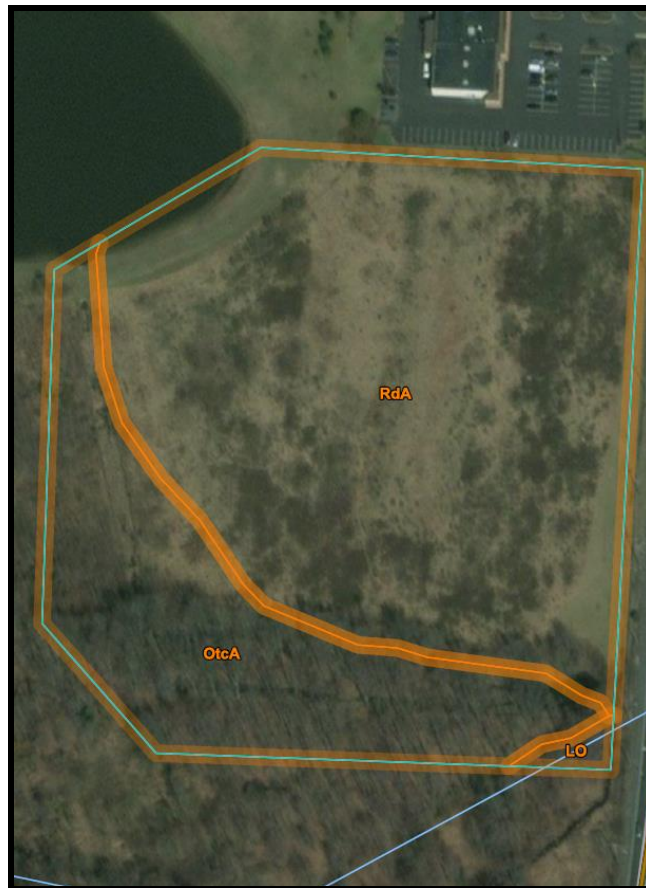
**Figure 9: Soils Map**

The mapped soils are shown below, the majority of the site is mapped as well drained soils with poorly drained soils along the western and southern boundary (see details in attached soil report).

The soils found on the site have been disturbed and appear to be imported fill material in some areas. Hydric soils were found in the areas mapped as wetlands.

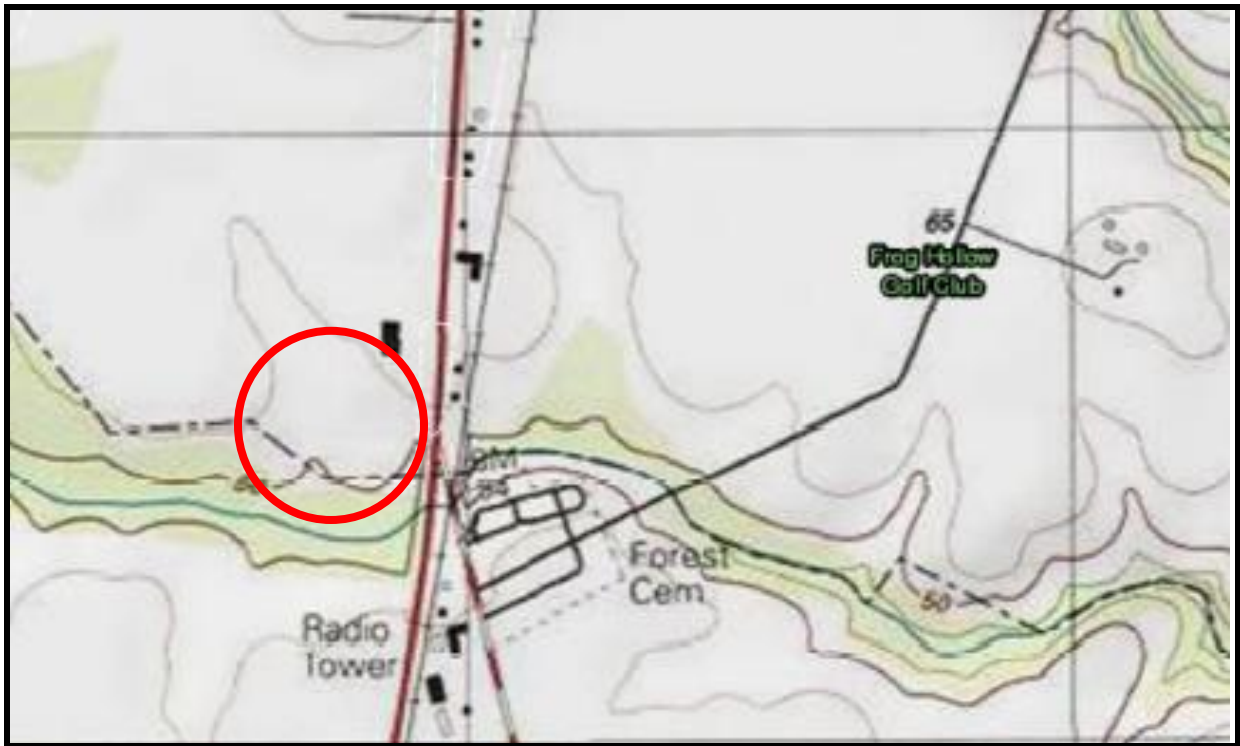
Figure 11: USGS Map

The USGS Mapping indicates that the site occupies a flat spot on the landscape and drains to an unnamed tributary to Drawyer Creek. A ditch on the western portion of the property drains the storm water management pond to Summit Bridge Road where it connects to the unnamed tribu.

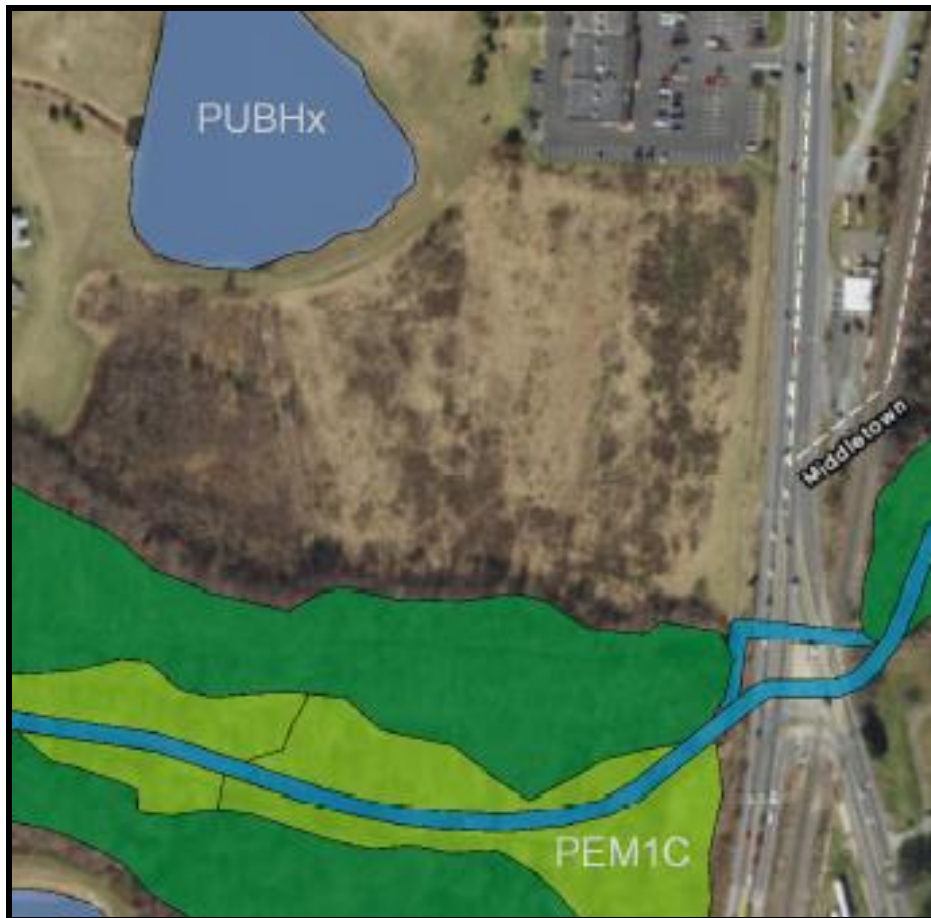
**Figure 12: NWI Mapping**

Additionally, the NWI Maps depict wetlands along the unnamed tributary.

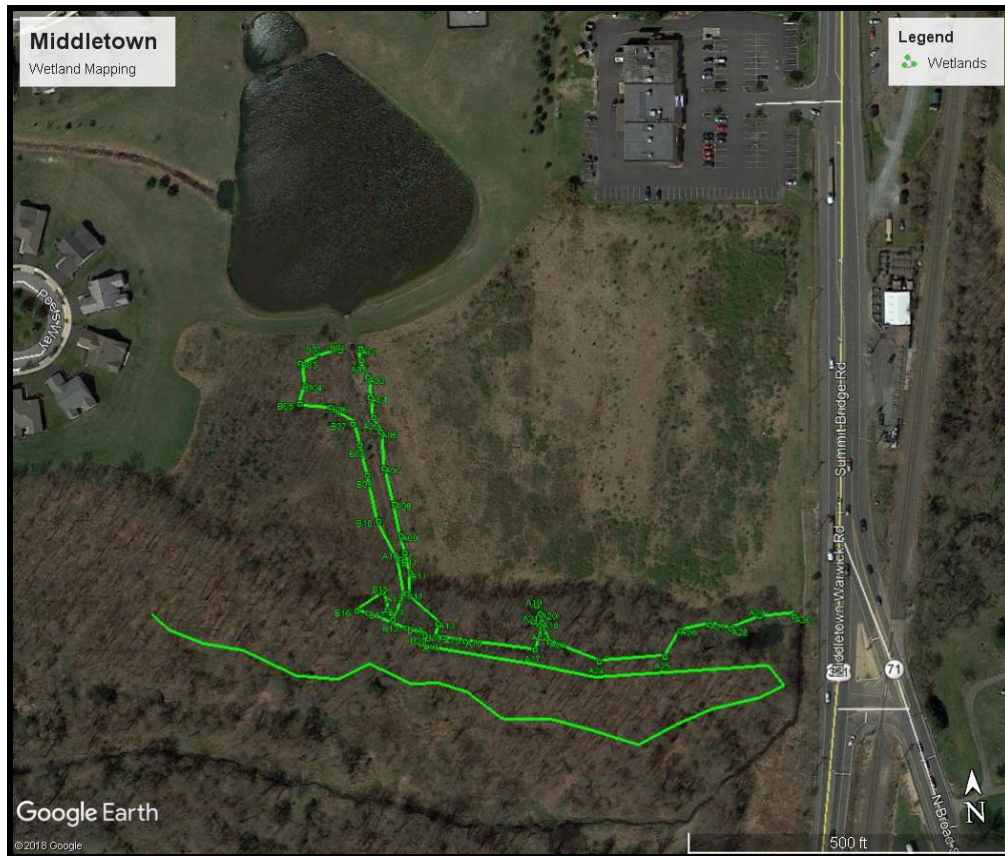
**Figure 13: Wetland Mapping**

Watershed Eco flagged the wetlands encountered on the site and located the flags with handheld GPS (Figure 13).

Based on the site investigation and collected data, it was determined that Waters, including wetlands were found on the site. These features were associated with the drainage ditch below the pond to Summit Bridge Road and and the unnamed tributary.
